Manhole Inspection Summary

Manhole # S33CC_025MH

Location Address: **1150 CATHEDRAL ST**

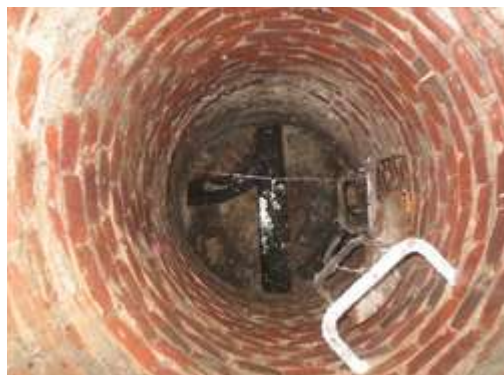
Top View

Corroded steps. Evidence of surcharge - Bench debris. Barrel infiltration. Channel debris.

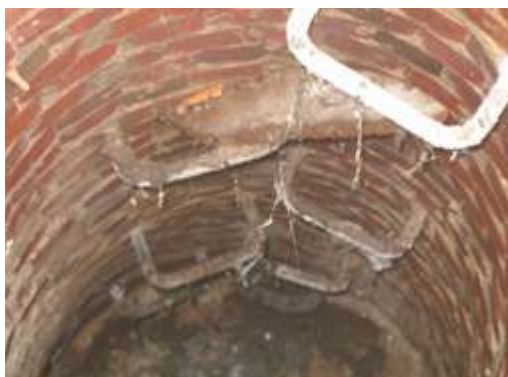
Defect

Corroded steps. Barrel infiltration.

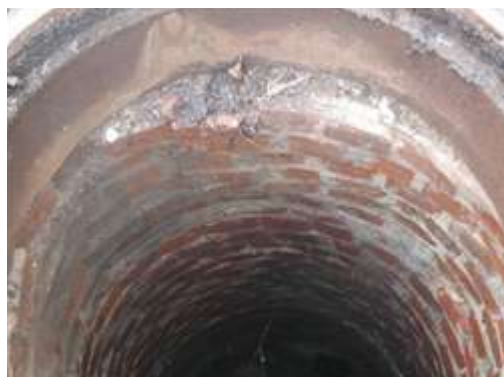
Defect

Frame leaks. Frame offset. Adjustment deterioration and infiltration. Corbel infiltration.

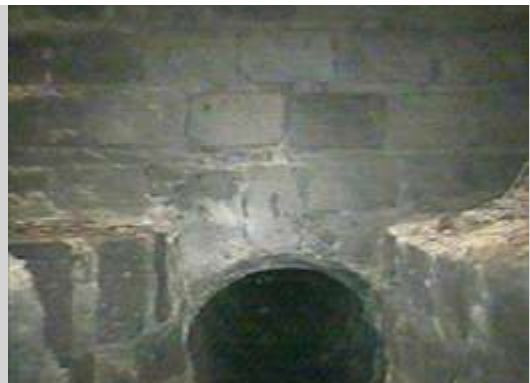
Pipe Out @ 12 O'Clock

Infiltration: **Evidence** Pipe Seal Cond: **Unknown**

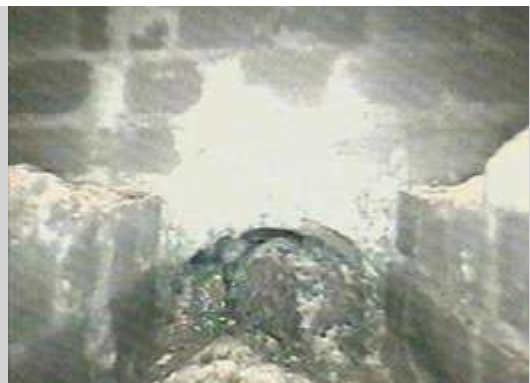
Pipe In @ 6 O'Clock

UNABLE TO GET MEASUREMENT DUE TO
DEBIS IN PIPE

Deposits: ☐ None ☒ **Mud** ☐ Sludge ☒ **Debris** ☐ Grease

Silt Depth: **8** (in.) Deposits Extent: **Heavy**

Infiltration: **Evidence** Pipe Seal Cond: **Unknown**

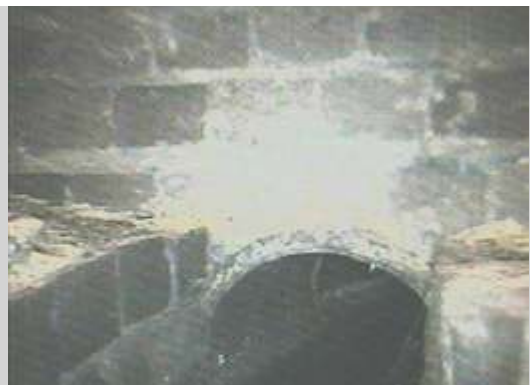
Pipe In @ 9 O'Clock

Infiltration: **Evidence**
